Volvo 641 & 295 Insert
M-MIS-90253

Volvo Ignition Control Unit

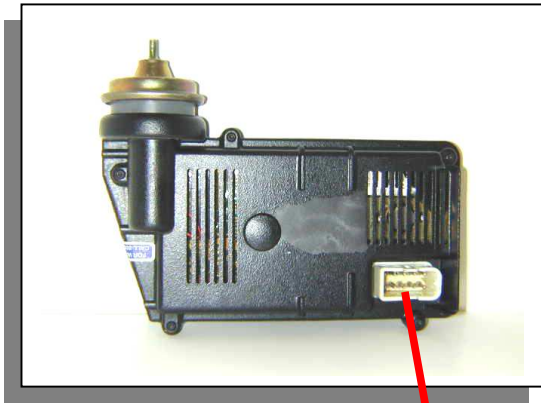
If unit is intermittent or not working properly, check if **PIN CONTACT SLEEVES** are installed for proper connection.

Pin Contact Sleeve
Volvo Part Number:
1324909

Male Connector

Female Connector

To replace or install Contact Sleeves, follow these instructions:

- 1- Clean old dirt (grease) from *female connector* and then apply new grease before plugging unit back for protection of the connectors.
- 2- Check to see if old PIN CONTACT SLEEVES are already in *female or male connector* from previous installation.
- 3- If PIN CONTACT SLEEVES were left on the old unit *male connector* remove them and reuse in the same position where they were taken off.
- 4- If PIN CONTACT SLEEVES are already in the *female connector*, you do not need to install new ones, but make sure each pin has one.
- 5- If PIN CONTACT SLEEVES are missing, you may order it from your nearest Volvo dealer. (see part number next to picture)
