# Analog and Digital Instrument Cluster Repair Service

Two-Year Warranty in Parts & Labor. Service completed in 48 hours.

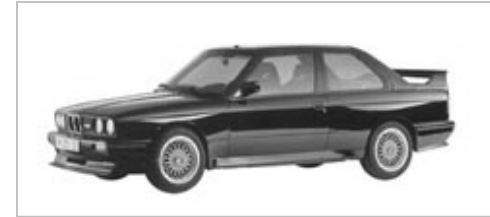
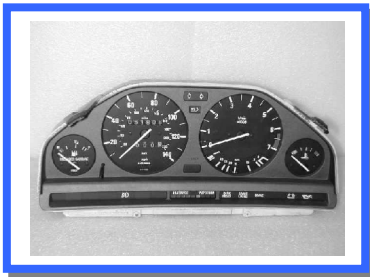
- **BMW E30 (3 Series)**

Complete Cluster

Our repair service consist of replacing both the main service indicator (SI) Board P # 6211 1 394 268 and the conductor plate (P# 6211 1 372 255). For this model, we use our aftermarket “NEW” battery-less version SI Board replacement part # 26801.

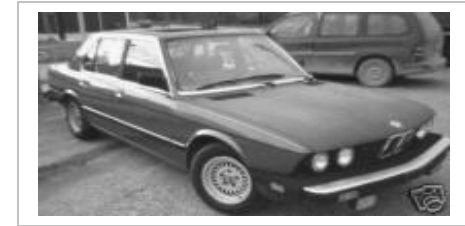
- BMW E23, E24 and E28 (5, 6 and 7 Series)

Our repair service consists of replacing both the main service indicator (SI) Board P # 6211 1 394 273 and the conductor plate (P# 6211 1 377 634). For this model, we use our aftermarket “NEW” battery-less version SI-Board replacement part # 27301.

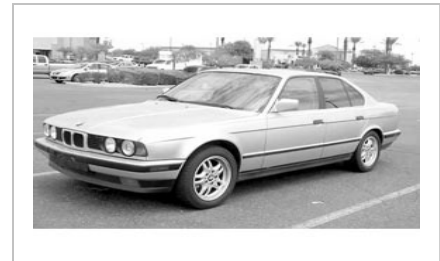
- **BMW E32 and E34 (5 and 6 series)**

Our service consists of replacing or repairing the existing mother board (P# 6211 1 390 082) and/or conductor plate (P# 62 11 1 378 566).

Note: The code-plug located inside plastic housing of the brown female connector (harness).

Vehicle mileage, digital odometer information, SI light status, etc. are stored in a code-plug (a non-volatile memory); meaning that the information will remain stored even if unplugged or disconnected from 12V.

The code plug eliminated the need for batteries used in early models. Models before 1989 have the code plug located inside the **brown connector** of the cluster, later models have it plugged in the backside of the mother board.

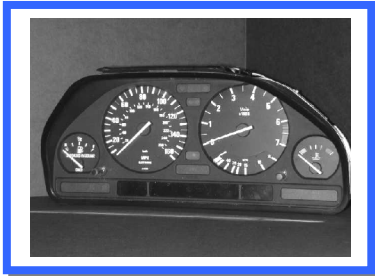
Our service consists of replacing or repairing the existing mother board (P# 6211 8 351 576).

Note: The code-plug is located in the back-side of the mother board.

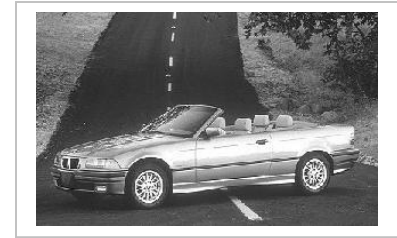
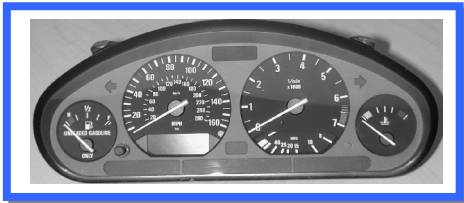
### BMW 3-Series E-36 Chassis

Our service consists of repairing the existing mother board to correct any instrument malfunctioning, including digital displays.

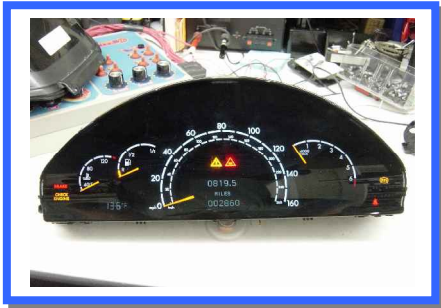
220-Chassis Models S430, S55AMG, S500 & S600

Our service consists of repairing the existing mother board to allow full illumination of the instruments and displays.
