CURTIS 1264-5404/5405/5407

If installing this controller in an EZ-GO workhorse vehicle please follow the procedure below prior to installing this replacement controller.

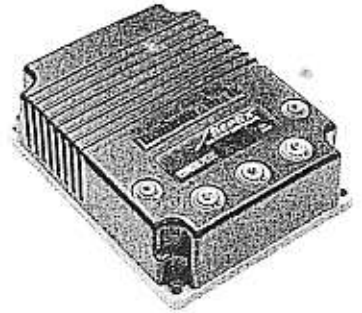
The factory wire harness under the cart which leads to the key and F/R switch has a 3-way splice in it that has been found to become intermittent. This wiring problem will cause permanent damage to the motor controller left unrepaired.

Prior to installing a replacement controller remove the nylon cable shielding from the main controller harness, and locate the three wire splice found where the harness is routed under the vehicle. This connection must be re-terminated to ensure motor controller longevity. After these wires are fastened solidly wrap the harness with electrical tape or other means of wire protection.

Failure to not follow the above procedure will cause the controller to fail prematurely and warranty will not be honored.
